Survival Factors

Airbag Safety Study Factual Report

May 20, 2009

Location: Steamboat Springs, CO
Aircraft Type: SR-22
Accident Date: 2/14/09
Accident Time: 1115 MST
Accident Number: N486CD, CEN09LA165
Airbag Equipped: Yes

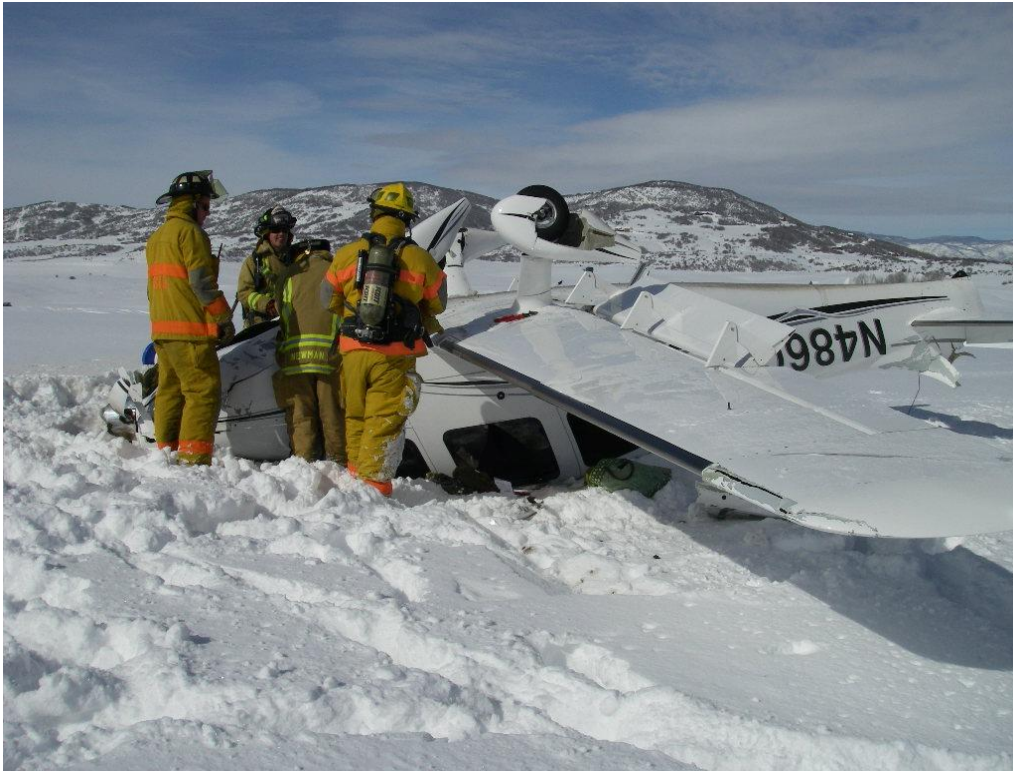
See figures 1 and 2 for an overall view of exterior damage. There was wing tip damage and skin damage to both left and right wings. The left wing tip exhibited impact damage with an approximate 45 degree buckle from the forward outboard tip angling inboard on both the upper and lower skins of the wingtip. The right wing tip exhibited impact damage and aft buckling at the leading edge. The lower skin of right wing tip had a 45 degree buckle starting on inboard leading edge of tip extending outboard.

Figure 1- An on-scene photograph of the inverted accident airplane looking at the right side of the aircraft.

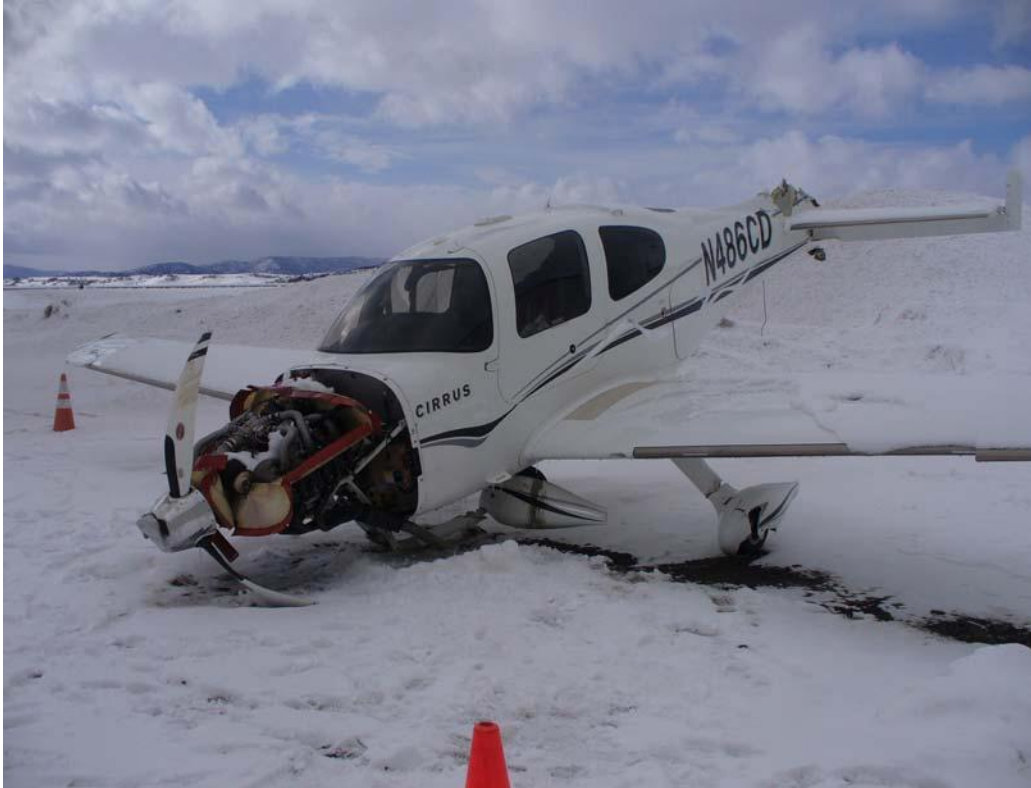
Figure 2 – A post-recovery photograph of the front and left side of the aircraft.

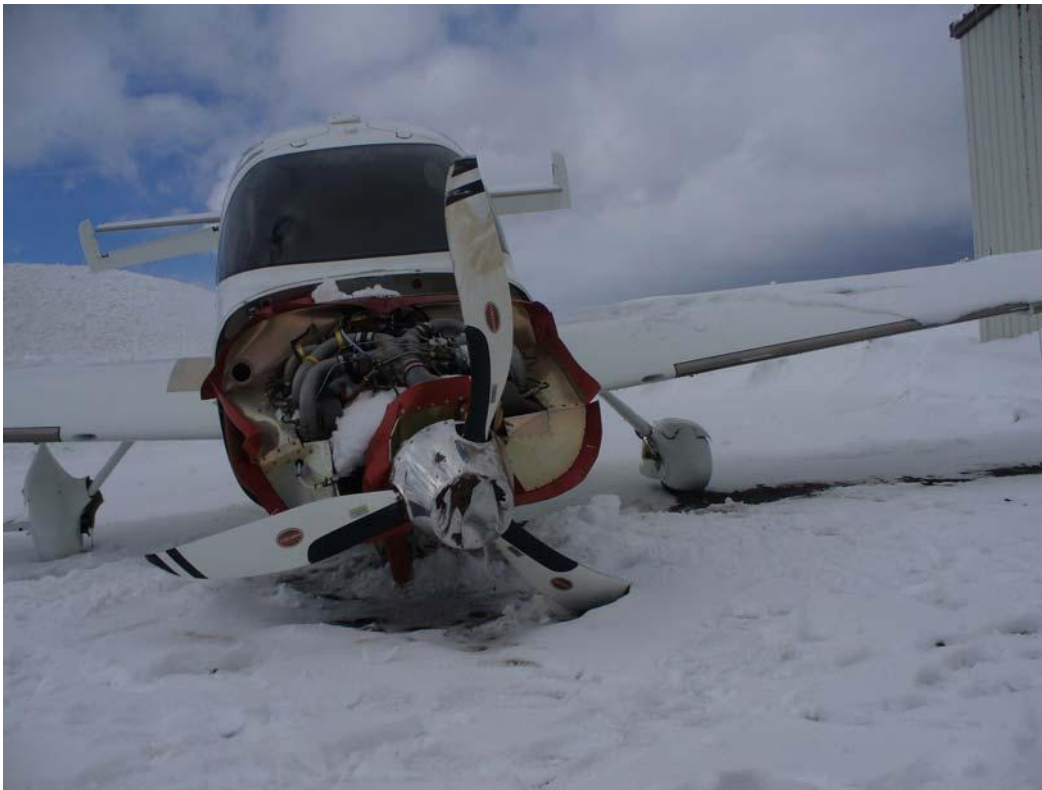
The nose of the airplane was shifted to the left including the engine, propeller, and spinner (Figure 3). The spinner had aft crushing with soil embedded in folds of metal. All three blades had aft bending at about 10" from the hub and one blade had chordwise scratching on the outboard 6" of blade, and gouges on the leading edge. This blade also had spanwise scratching from hub outboard to within 6" of blade tip.

Figure 3 – A post-recovery photograph of the front of the aircraft showing the nose/engine displacement

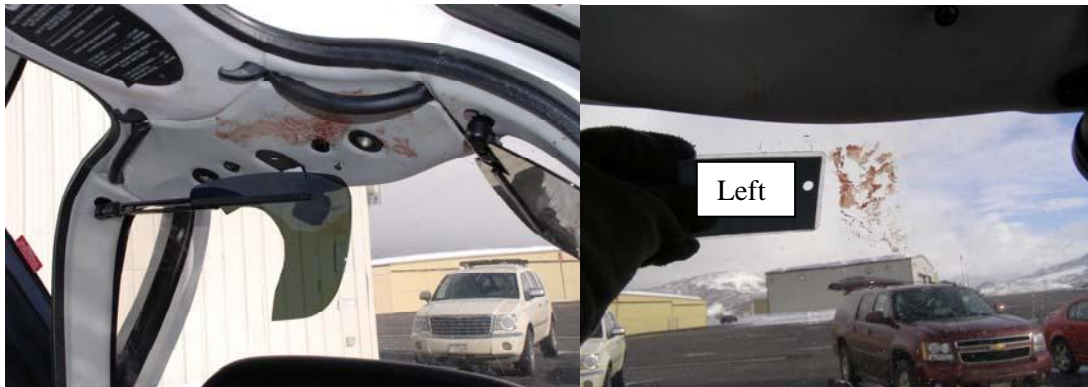
Overall, there was very little interior cabin damage. The headliner was torn back and displaced. On the left side, the sun visor shattered and there was a small amount of blood on the windscreen at pilot eye level. (Figure 4). There was also a small displacement of left bolster panel/center console (Figure 5).

Figure 4 – Left side photo shows headliner with bloodstains, and broken sun visor on left side. Right side photo shows blood stain on windscreen, which is obscured behind the broken sun visor on left side photo.

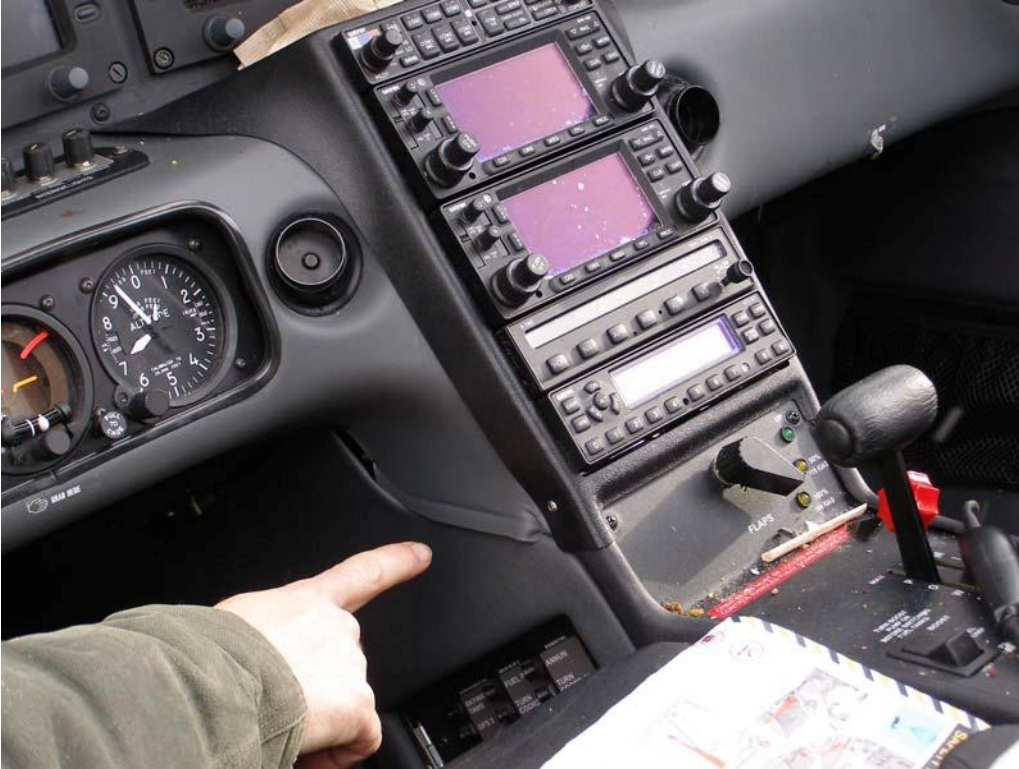
Figure 5 – Displacement of left bolster panel/center console.

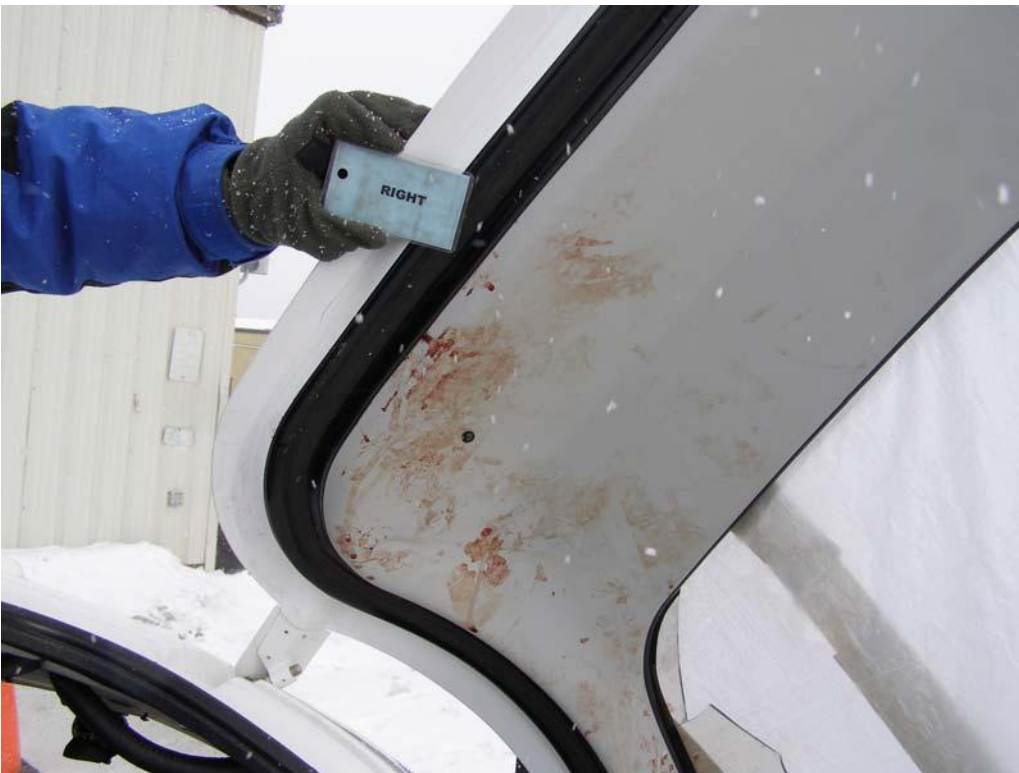
On the right side, there were many blood stains, mostly on right front side and inside right door (Figure 6). There was a blood stain on right headliner near the grab-handle and eyeball light 14" wide and 4" front to aft. There were small blood spots on bolster and inside right portion of console at level of the transponder. There was also a small spot on right bolster panel lower edge to the left of the "grab here" placard (Figure 7). The right front door window was broken in a V-shape (Figure 8) and the pilot stated that he had broken the window with the egress hammer from the left seat.

Figure 6 – Blood stains on inside of right front door.

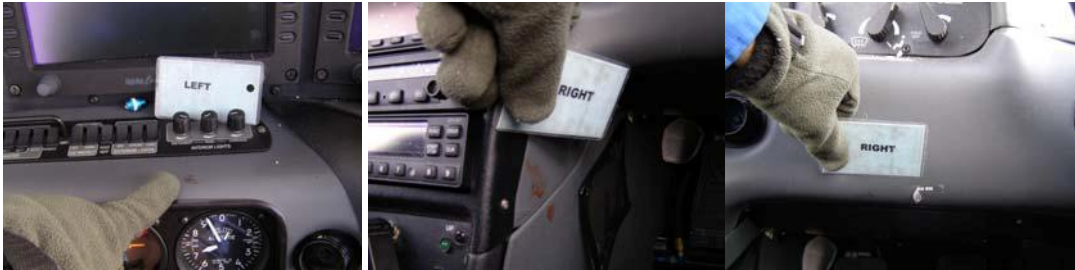
Figure 7 - Various blood spots on the right front interior side of the cabin.

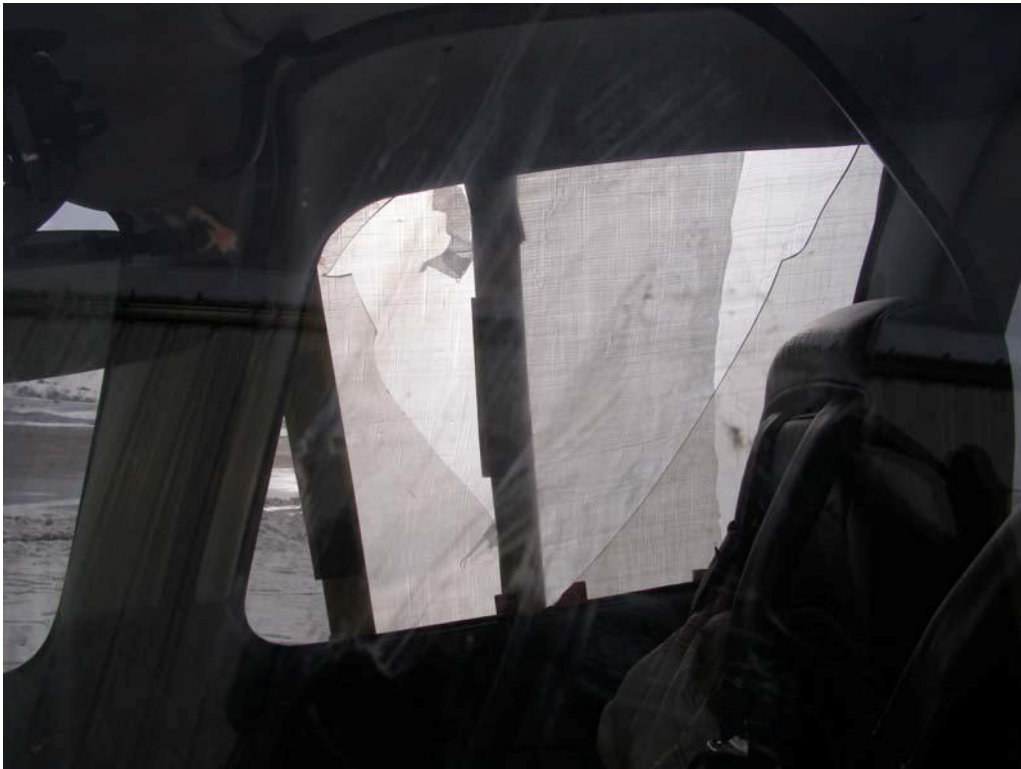
Figure 8 – Broken right front window. (This window was used for egress.)

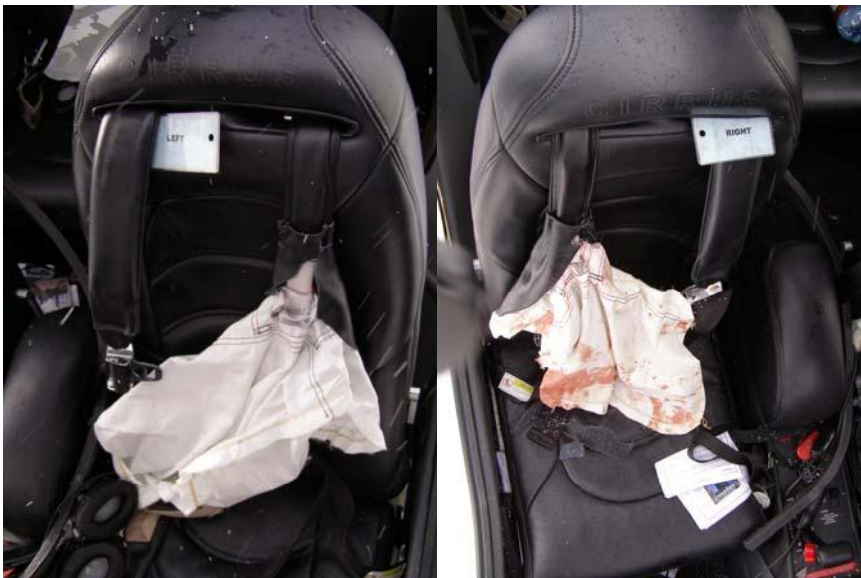
Figure 10 – Front Seats

Overall, there was no seat displacement and very little damage to seats in general with the exception of slight deformations of the forward edges of the energy absorption modules on both right and left front seat pans, which are listed below.

Left seat: front right corner deformed 0.3", mid point deformed 0.4", left front corner deformed 0.2".

Right seat: left front corner deformed 0.25", center deformed 0.3", right front corner deformed 0.15".

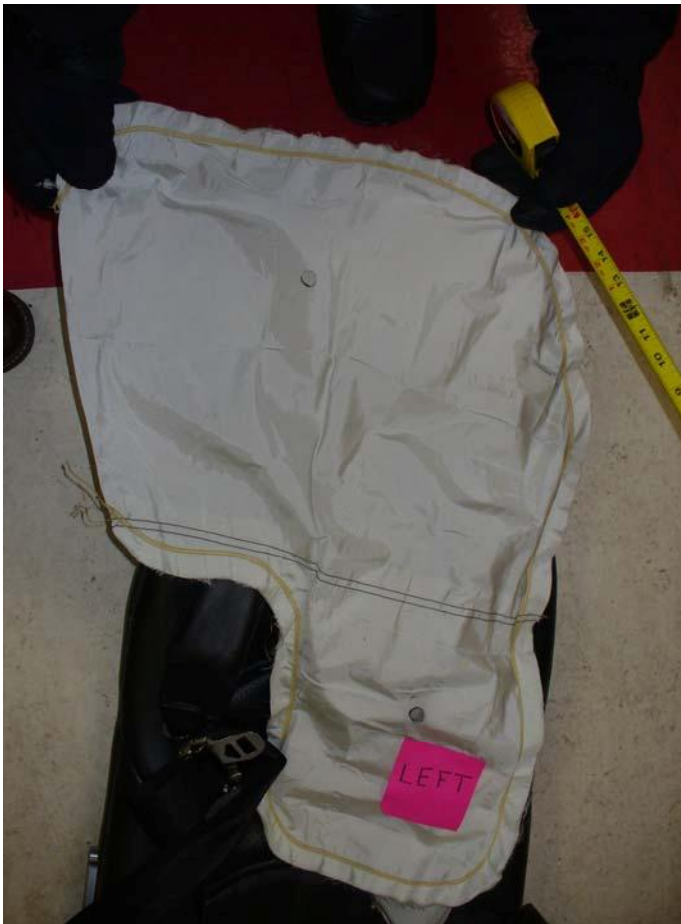
The two front seats were equipped with restraint mounted airbag systems that deployed from the outboard shoulder harness. The airbags are in the shape of an inverted L. Both front seat airbags deployed. On the left front airbag, the seams were observed to be intact with no stitching damage. On the instrument panel side of the airbag (Figure 12), there was a small blood spot next to the lower lobe vent hole approximately 7" from bottom of bag. There was no squaring of the bottom vent hole and minor squaring (3 to 4 threads) of the top vent hole. On the occupant side (Figure 13), there was a 0.5" in diameter blood spot 3" from the outboard edge and 6" from the top. There were also black scuff marks from 2.5" to 4" from the top of the bag at 5" from the outboard edge of the bag.

Figure 12 – Left front airbag, instrument panel side.

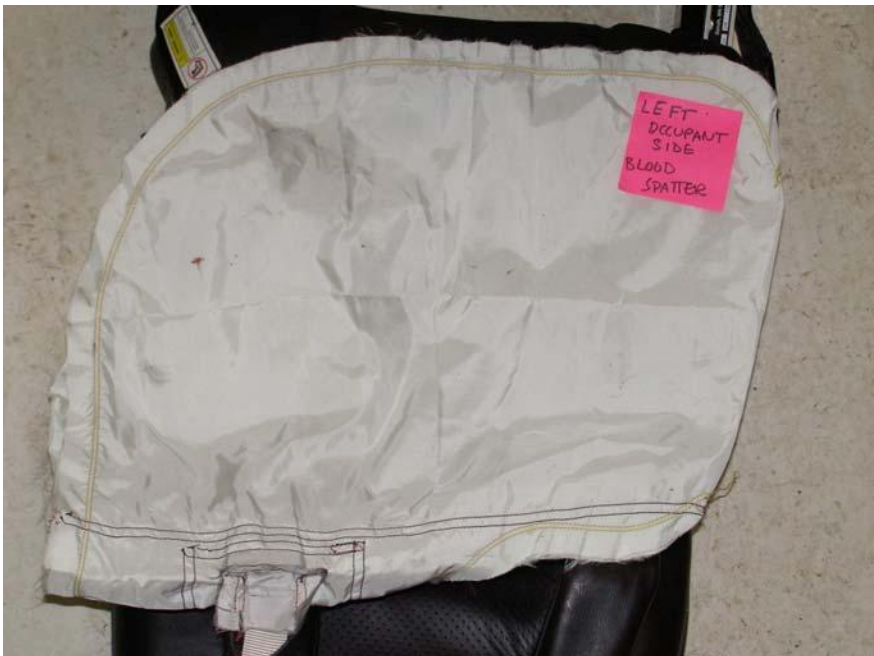
Figure 13 – Left front airbag, occupant side.

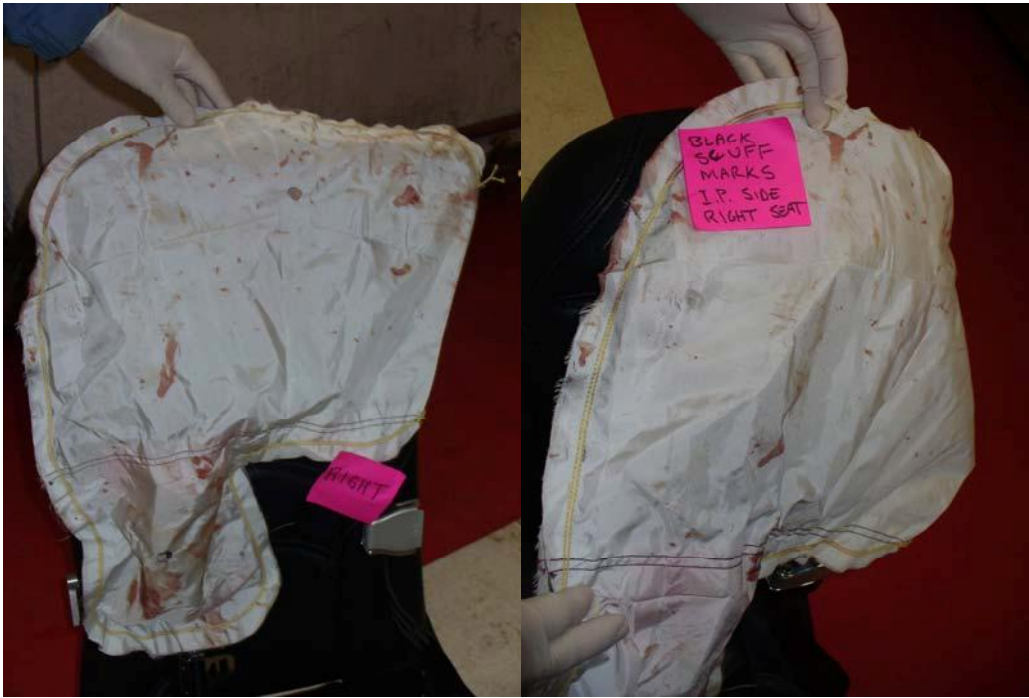
On the right front airbag, the seams were intact. On the instrument panel side (Figure 14), both the upper and lower vent holes had minor squaring (2-3 threads). There were also some small scuff marks on the instrument panel side. On the occupant side (Figure 15), there was a large amount of blood and two scuff-marks: The first scuff mark was 1.5" from the outboard edge to 3.5" from the outboard edge starting 10" down from the top to 12.5" from the top. The second scuff mark was 6" from the outboard edge to 8.5" from the outboard edge and 12" down from the top to 14" down from the top. Finally, there were a few tiny blue spots on the bag.

Figure 14 – Right front airbag, instrument side. Right side photo shows detail view of small scuff marks.

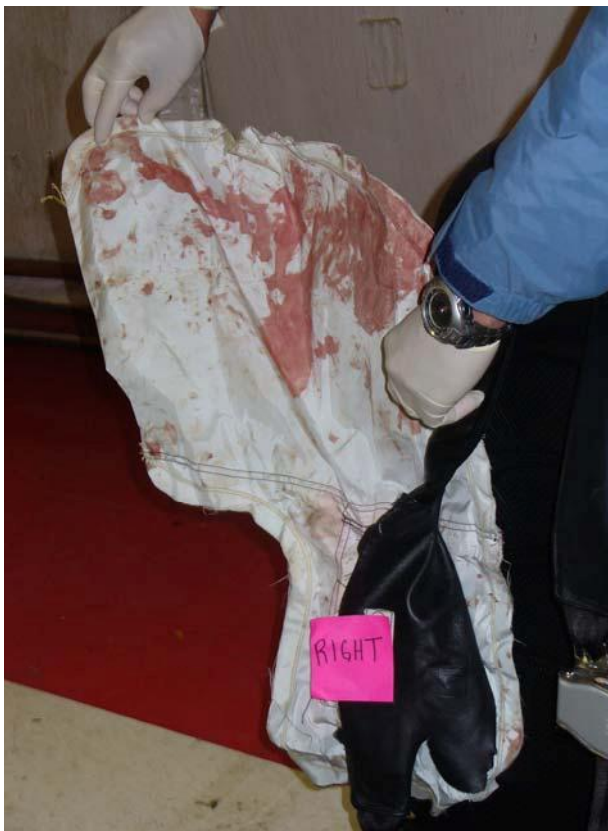
Figure 15 – Right front airbag, occupant side.
